AN EXPERIMENTAL INVESTIGATION OF CHEMICAL REACTION

BETWEEN PROPELLANT TANK MATERIAL AND ROCKET

FUELS OR OXIDIZERS WHEN IMPACTED BY SMALL

TECHNICAL NOTE D-1882

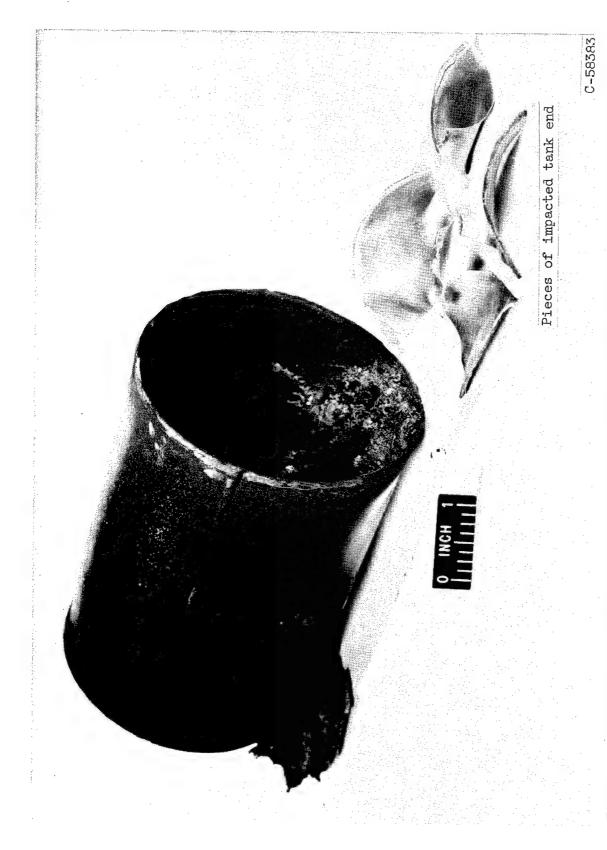
being scattered about the immediate area. The third frame of figure 8(a) (7 msec after impact) shows some of the pieces of the end cap being explosively detached from the tank. Figure 9 shows the extensive damage that resulted from the impact; the tearing or curling of the impacted surface resulted in the ultimate failure of the welded region joining the end cap to the cylinder. Despite the generally violent physical and chemical reactions, there were no signs of a specific interaction of the impacted end cap with the propellant.

Figure 9. - Results of impact by steel projectile into aluminum tank filled with Hercules CLW. Test 7.

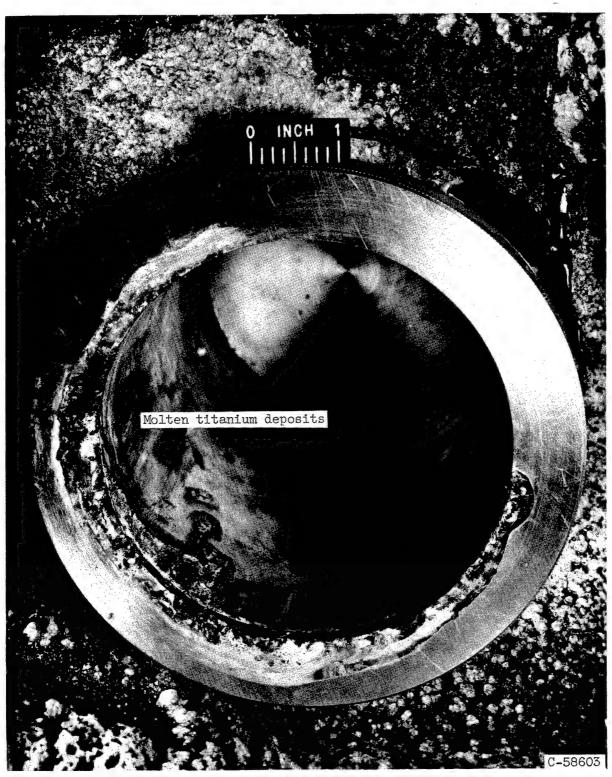
Impacting projectile material: The first impact of a titanium tank wall was made with a 0.219-inch-diameter steel sphere at a velocity of 5800 feet per second. The condition of the tank after the impact and the subsequent titanium - liquid-oxygen reaction is shown in figure 12. Molten titanium, produced during the violent reaction that resulted, deposited on the retaining nut and the inside of the tank and caused the damage shown in the figure. The insulation that surrounded the tank was slightly scorched as a result of the vigorous burning, and for all subsequent tests the insulation was covered with a thin stainless-steel sheet to prevent such damage.

Figure 12. - Condition of tank after impact and penetration of titanium wall of tank filled with liquid oxygen. Test 8.

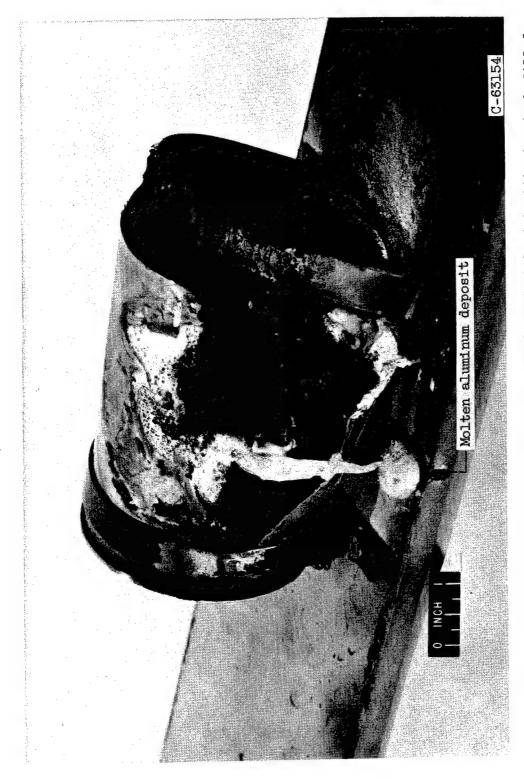
Hercules CLW. - Impact tests 34 to 36 were made on a grain of Hercules CLW propellant encased in a 0.020-inch-thick titanium (5Al-2.5Sn-Ti) shell. Including the 0.25-inch thickness of the inhibitor, the grain diameter was about 3.75 inches. As in all other tests, the tank was mounted so that the cylindrical axis was in a horizontal position; however, the impacts were made on the cylindrical surface of the tank rather than on the tank end. Thus, the impacting particle would have to penetrate the inhibitor as well as the titanium shell before impacting the propellant.

Figure 16. - Damage resulting from impact by steel projectile into titanium tank filled with Hercules CLW. Test 36.
